Manhole Inspection Summary

Manhole # S47GG_002MH

Insp Date: **6/18/08 9:53 AM**

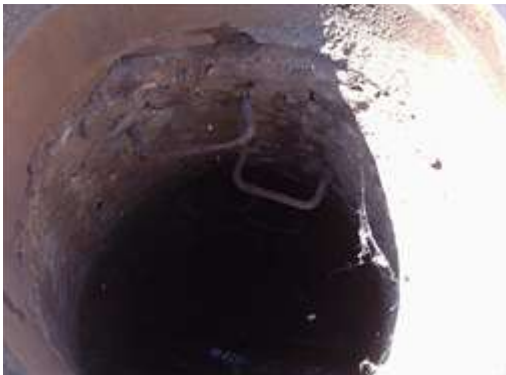
Defect 1

deterioration

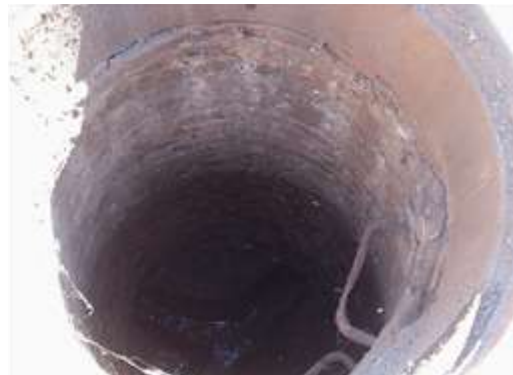
Defect 2

Condition: ☐ Sound ☐ Cracked ☐ Root Intrusion ☒ **Loose Brick** ☐ Deteriorated

Infiltration: ☐ None ☒ **Joint** ☐ Cracks ☒ **Mortar** ☐ Roots ☐ Wall

loose bricks

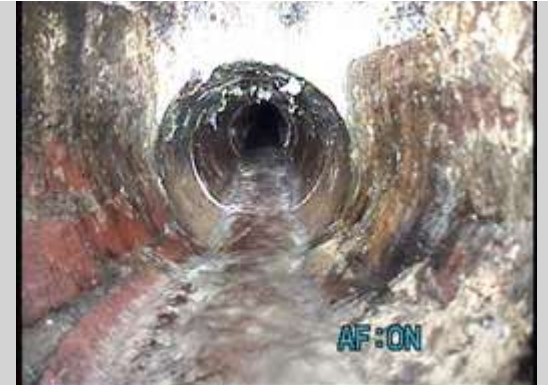
12 O'Clock Outflow

Pipe Height: **8.4** (in.) Rod and Bar (Angled)
Pipe Material: **Clay** ☐ Pipe Lined
Invert Depth: **9.70** (ft.) Flow Characteristics: **Fast**
Deposits: ☒ None ☐ Mud ☐ Sludge ☐ Debris ☐ Grease
Silt Depth: (in.) Deposits Extent:
Infiltration: **None** Pipe Seal Cond: **Sound**

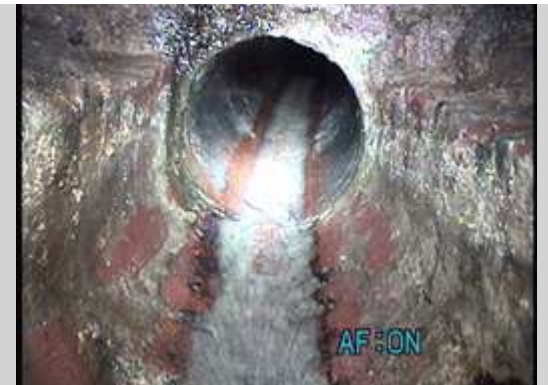
6 O'Clock Inflow

Pipe Height: **8.4** (in.) Rod and Bar (Angled)
Pipe Material: **Clay** ☐ Pipe Lined
Invert Depth: **9.40** (ft.) Flow Characteristics: **Fast**
Deposits: ☒ None ☐ Mud ☐ Sludge ☐ Debris ☐ Grease
Silt Depth: (in.) Deposits Extent:
Infiltration: **None** Pipe Seal Cond: **Sound**

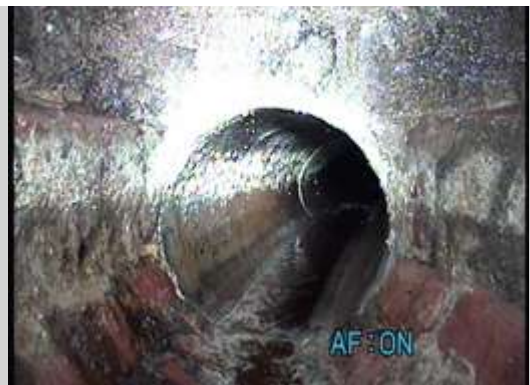
9 O'Clock Inflow

Infiltration: **None** Pipe Seal Cond: **Sound**
